# ANALYSIS OF CASING CHANGES: STYROFOAM VS PLASTIC CASING OF THE RS41

GRUAN ICM10 4/24/2018

NWS STERLING FIELD SUPPORT CENTER

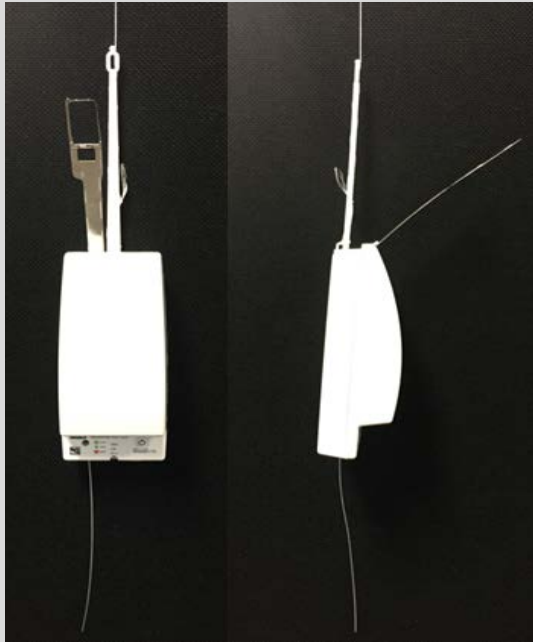
RS41 Plastic  
Weight ~100g

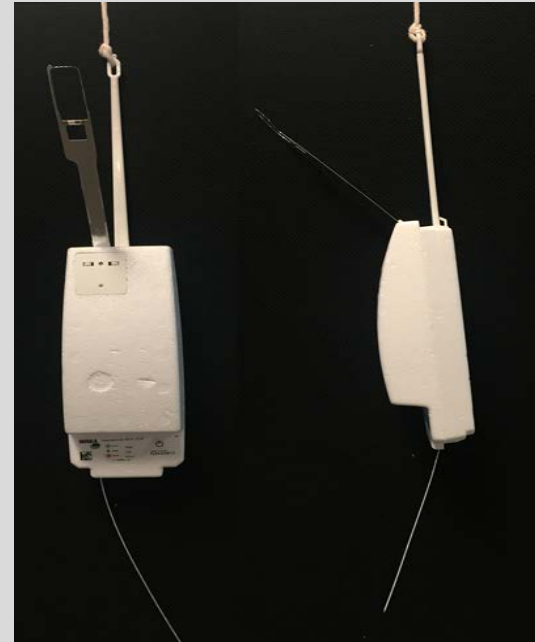
RS41 Soft and Light  
Expanded Polystyrene  
Weight ~80g

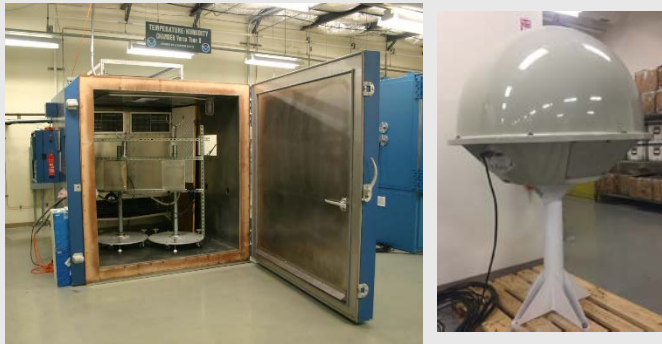
**Spray Test**

**Location: Sterling, Va**  
**# of Sondes: 9**

- **Purpose**
  - Moisture Intrusion
  - Performance of Temperature and Humidity Sensors
- **Spray Rate**
  - 10mm to 30mm per hour
- **Process**
  - Baselined
  - Placed in chamber after spray turned on
  - Radiosonde “released”
- **Test Completed when:**
  - RF stops transmitting for extended period of time
  - Software terminates flight due to missing data
  - Test duration >4 hours

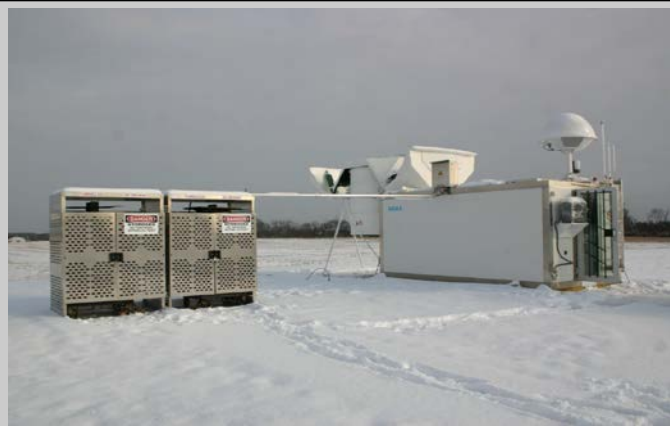
**Autosonde  
Integration  
Test**

**Vaisala AS15/MW41**  
**Location: Sterling, Va**  
**# of Sondes: 30**

- **29 Successful, 1 invalid flight**
- **Soft and Light: For a 600g balloon, average term height 33.6 km, average ascent rate: 314 m/min**
- **Plastic Case: For a 600g balloon, average term height: 29.1 km average ascent rate: 301 m/min**
- **No Gas Difference between plastic casing and Soft and Light flights**

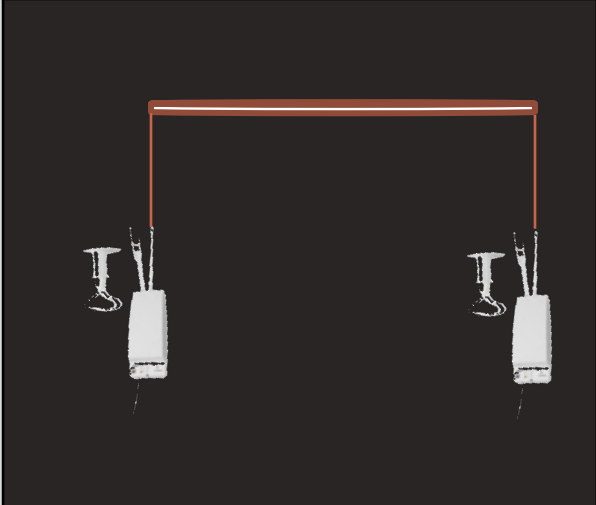
A diagram showing a horizontal orange line representing a flight path. Two white sondes are suspended from the line by thin wires, positioned symmetrically on either side of the center.	<p><b>Precision Test</b></p>	<p><b>Precision of Soft &amp; Light</b> <b>Location: Sterling, Va</b> <b># of Sondes: 20 (Soft &amp; Light)</b> <b># of Flights: 10</b></p>

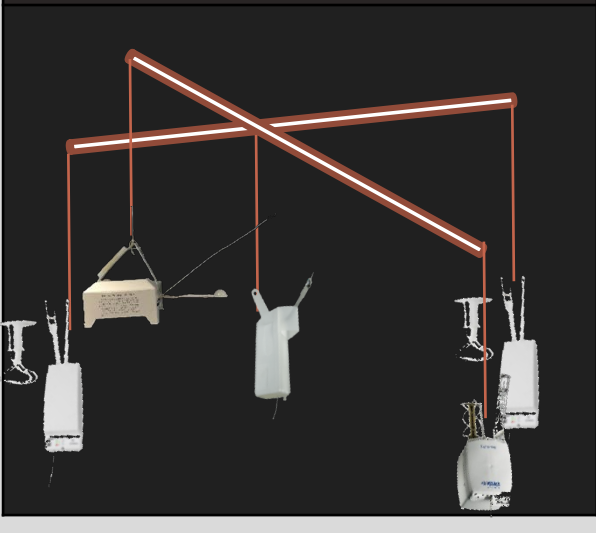
A diagram showing a complex orange structure representing a flight path. It consists of multiple intersecting lines. Several white sondes and one white plastic RS41 are suspended from the structure at various points.	<p><b>Precision Inter-comparison Test</b></p>	<p><b>Precision of Soft &amp; Light (above) compared to precision of Plastic RS41</b> <b>Location: Wallops Island, Va (Plastic)</b> <b># of Sondes: 66 (Plastic)</b></p>

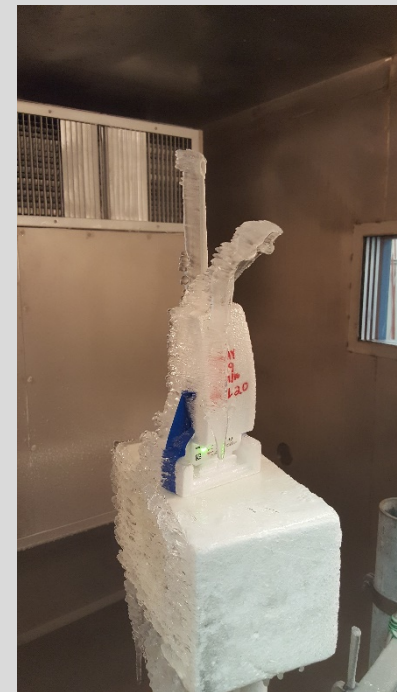
Profile (°F)	Date/Time	RH Sensor Failure	Unit Failure	Time On (s)
40° Steady	10/27 13Z	Y	N	63725
40° Steady	10/27 16Z	N	N	16332
40° Steady	10/31 12Z	Y	N	3450
60° Steady	11/13 19Z	N	N	14427
60° Steady	11/14 7Z	N	N	14605
40°↓20°	11/14 20Z	Y	N	14265
40°↓20°	11/15 12Z	Y	N	12186
30°↓20°	11/15 19Z	Y	N	16571
30°↓20°	11/16 11Z	Y	N	14432
